CONDITION SURVEY

The Old Tolbooth, Topcliffe

Condition Survey

Is1104-25 Condition Survey Report Rev A November 2025

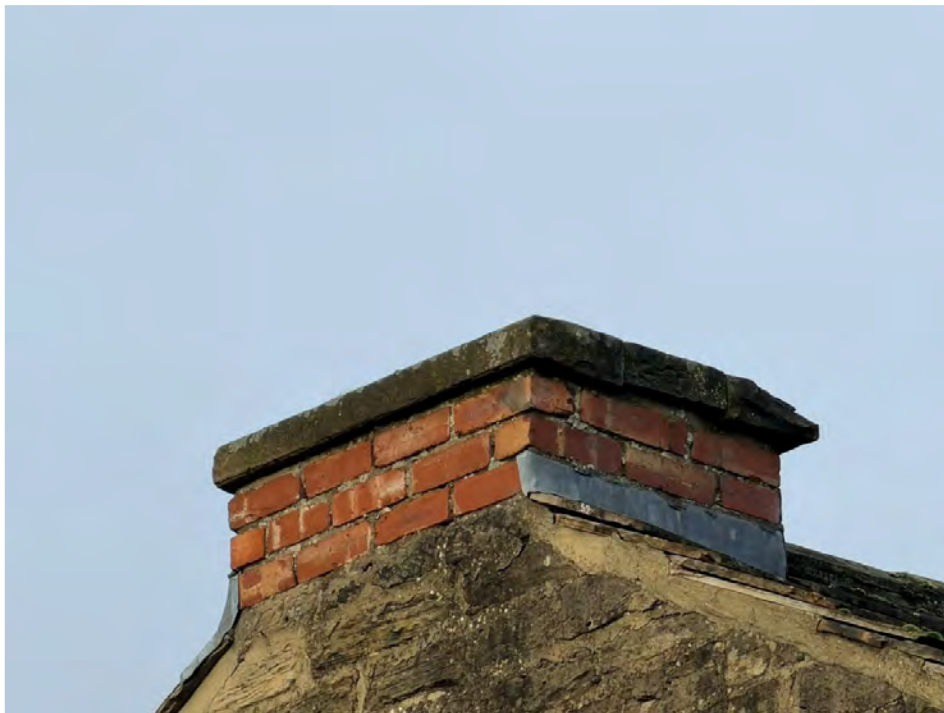
REDUCED CHIMNEY STACK

4.1	Chimneys										
4.1.1	1 No brick stack to front gable, appears to have been reduced in height and capped with stone slabs. Top of capping is not visible.	Pointing is friable, recessed, loose and missing in some areas. Capping stones are slightly uneven but appear to be securely bedded.	Carry out repointing in due course when access is available. Ensure flue is properly capped and vented and provide if required.	3			0.75			High-level access required

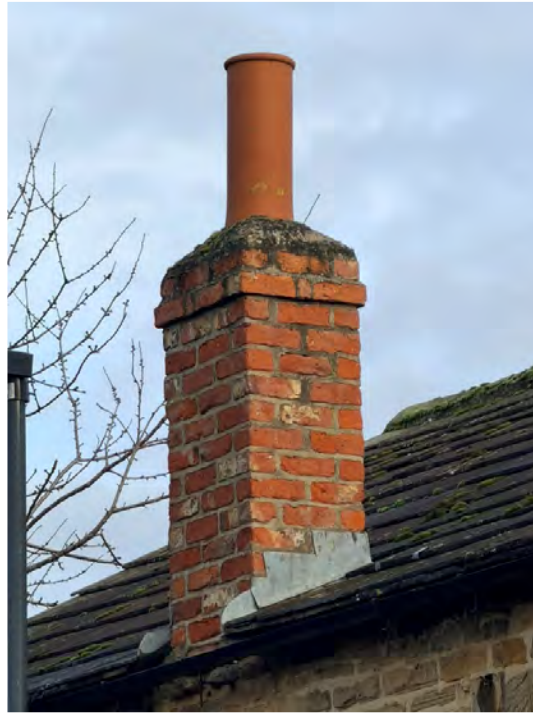
BROCK CHIMNEY STACK TO WEEST ELEVATIONS

4.1.2	Single brick stack to west elevation comprising 15 No courses with brick corbel and tall clay pot.	The stack is in serviceable condition and generally straight and plumb. Some moss growth noted to launching and minor loss of brick face in a few locations.	Clean off moss growth and repair defective bricks as required. Redundant/disused flue should be capped off and ventilated with cowl to the existing pot to prevent rainwater penetration.	4 4			0.25 0.50			High-level access required High-level access required

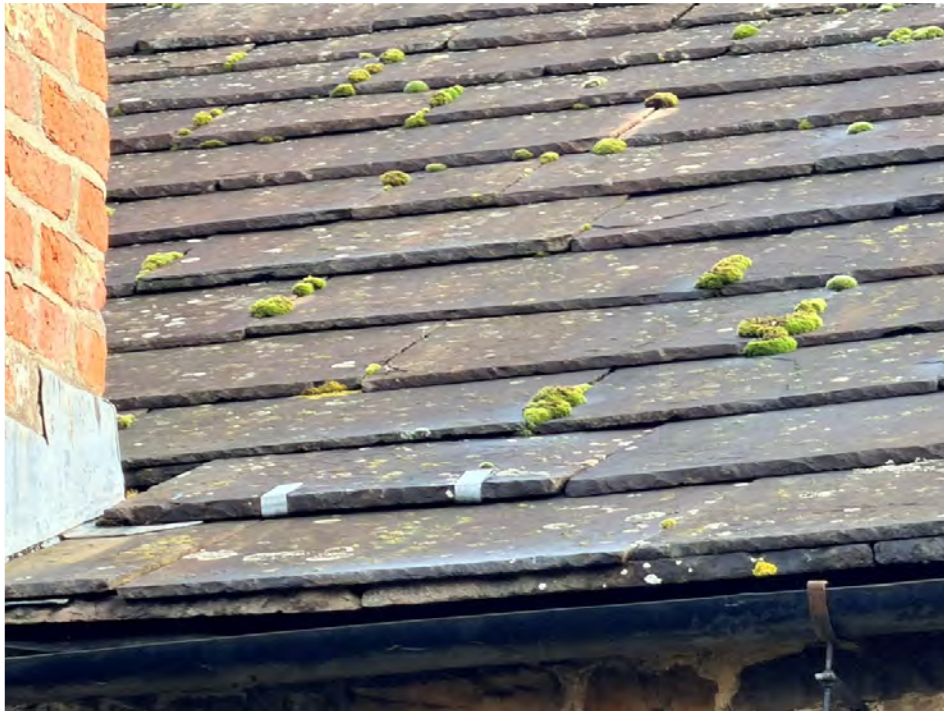
CLIPPED SLATE AND MOSS TO WEST ROOF SLOPE

4.2	Roof Coverings										
4.2.1	The main roof is dual pitched covered with stone slates, at approximately 33° pitch. Based on the presence of a bitumen underlay, it is likely that the roof covering has been renewed in the last 60 - 70 years.	Some light moss growth was noted on the west slope, with heavier growth on the east slope. The roof coverings are generally serviceable with no significant evidence of delamination to the slates.	Moss growth can accelerate deterioration of the roof coverings and should be carefully removed and a biocide applied. The roofs should be inspected annually for any damage and minor repairs carried out, ideally un preparation for each winter.	4 2		0.15	0.15	0.50 0.15	0.15	0.15	High-level access required

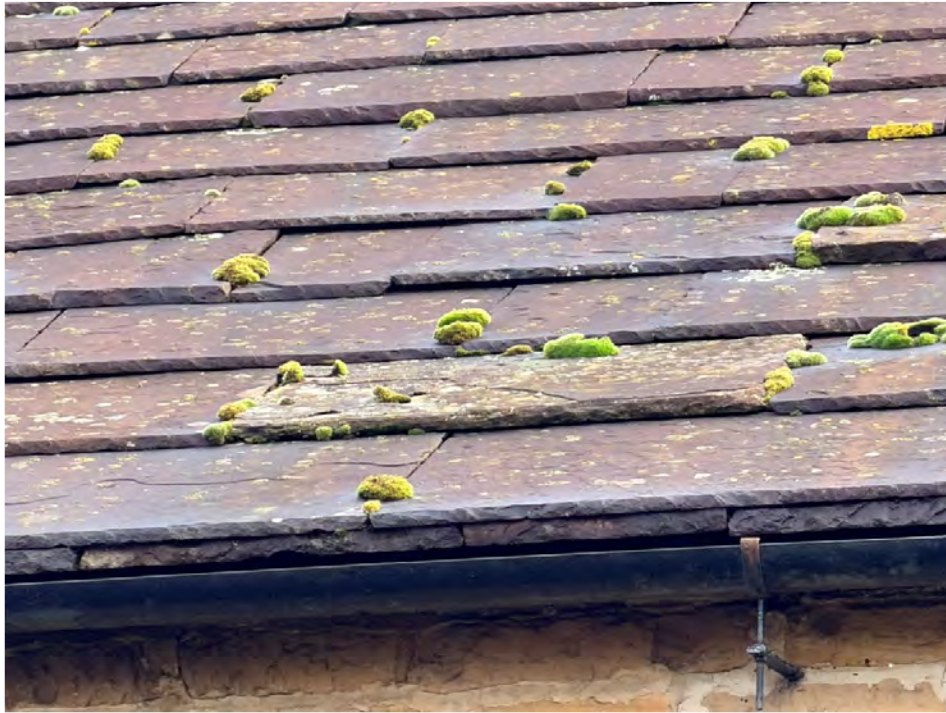
WEATHERED STONE SLATE

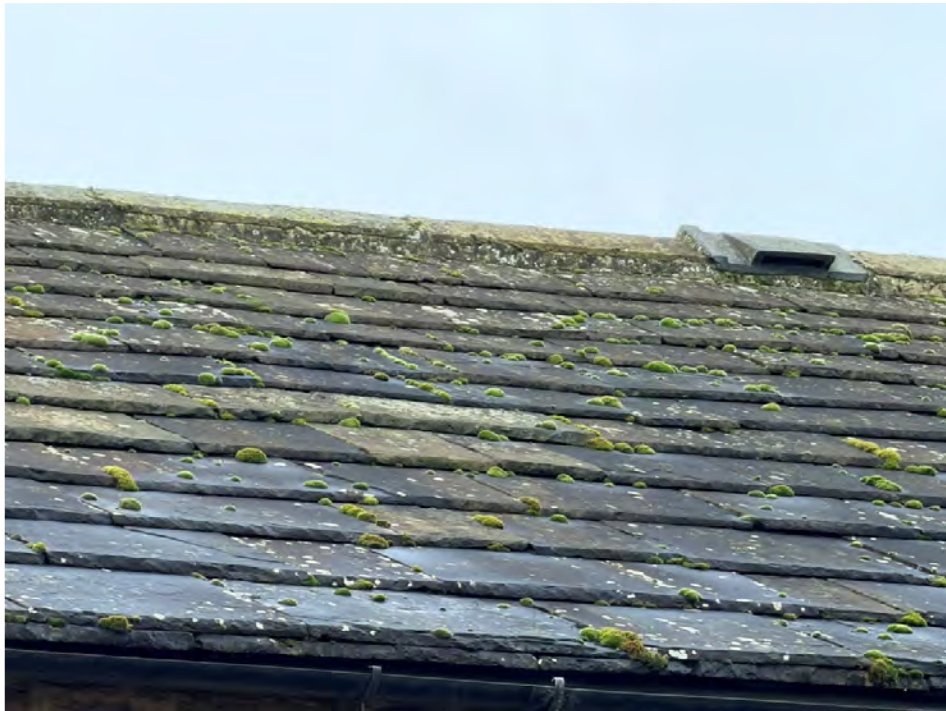
MOSS TO EAST ROOF SLOPE

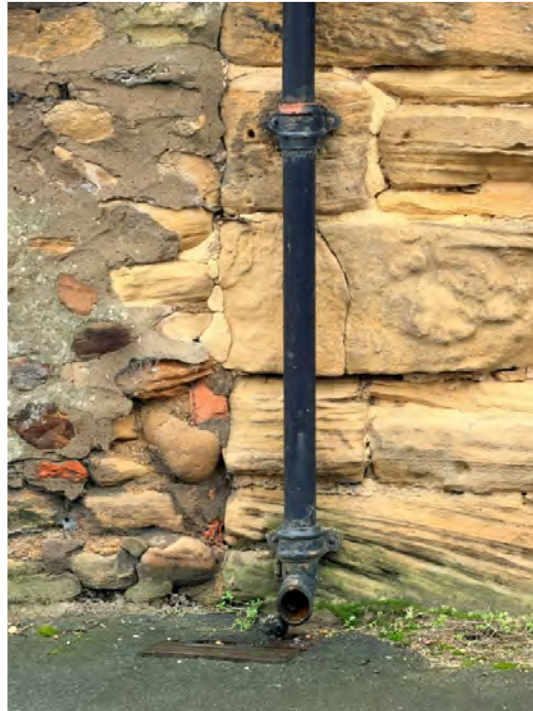
RAINWATER PIPE ON WEST ELEVATION WITH CORROSION AT JOINTS

4.3.2	Cast iron downpipes with some uPVC repaired sections.	<p>Generally serviceable condition. Some areas of minor corrosion noted and possibility of some leaks at joints etc.</p> <p>You should ensure that the gutters are seasonally unblocked of moss and other debris. As a matter of routine maintenance, gutters and downpipes should be periodically checked and maintained as follows:</p> <p>In general, you may find that the gutters and downpipes generally may not be of sufficient size to cope with the rising frequency of intense rain events, which can overwhelm undersized, blocked, or defective gutters.</p>	<p>Overhaul and redecorate. Allow for repairing joints and realigning as necessary to falls to outlets are provided.</p> <p>Clean out and clear away any vegetation growth. Clear, overhaul and seal joints as required.</p> <p>We recommend that consideration be given to replacing the gutters and downpipes with larger units in due course. The downpipes should be rationalised during replacement, and additional downpipes provided as necessary.</p>	3	Inc above

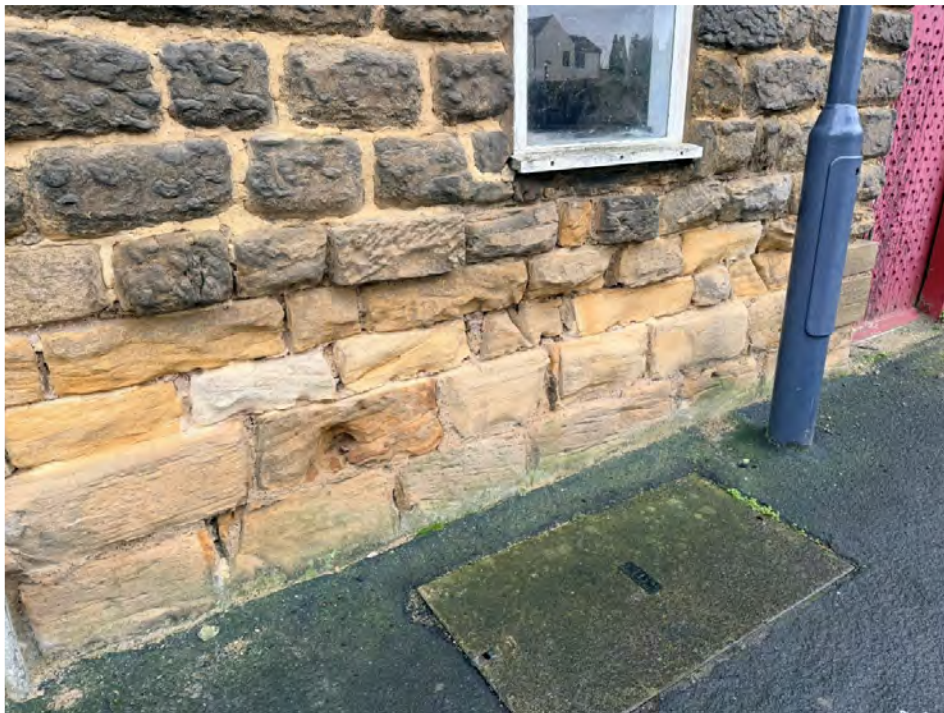
EROSION TO BASE OF WALL ON WEST ELEVATION

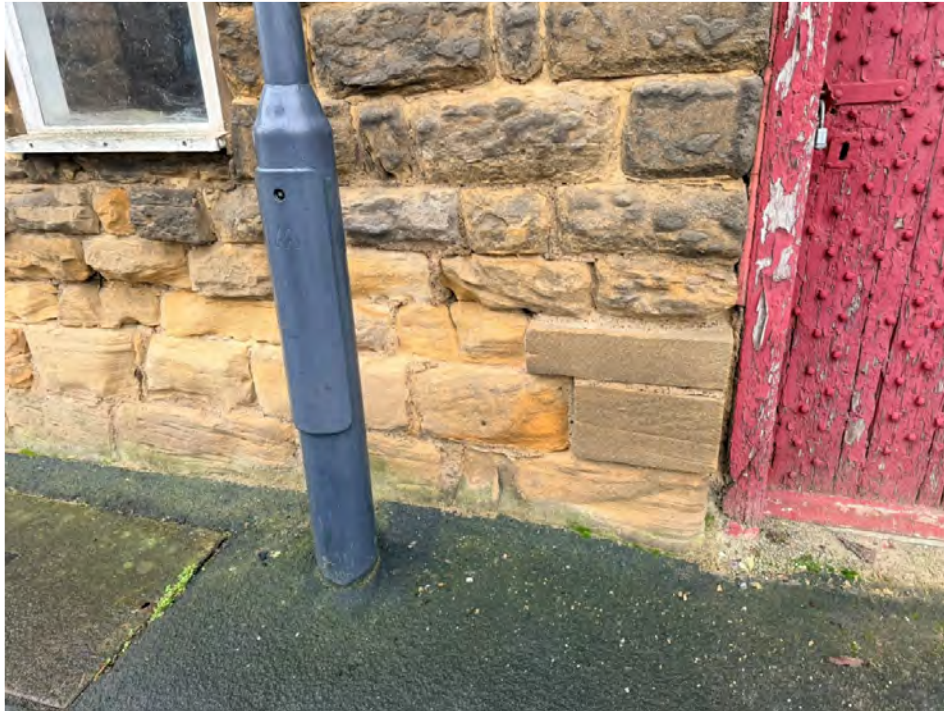
ERODED STONEMWORK AND REPLACEMENTS ON WEST ELEVATION

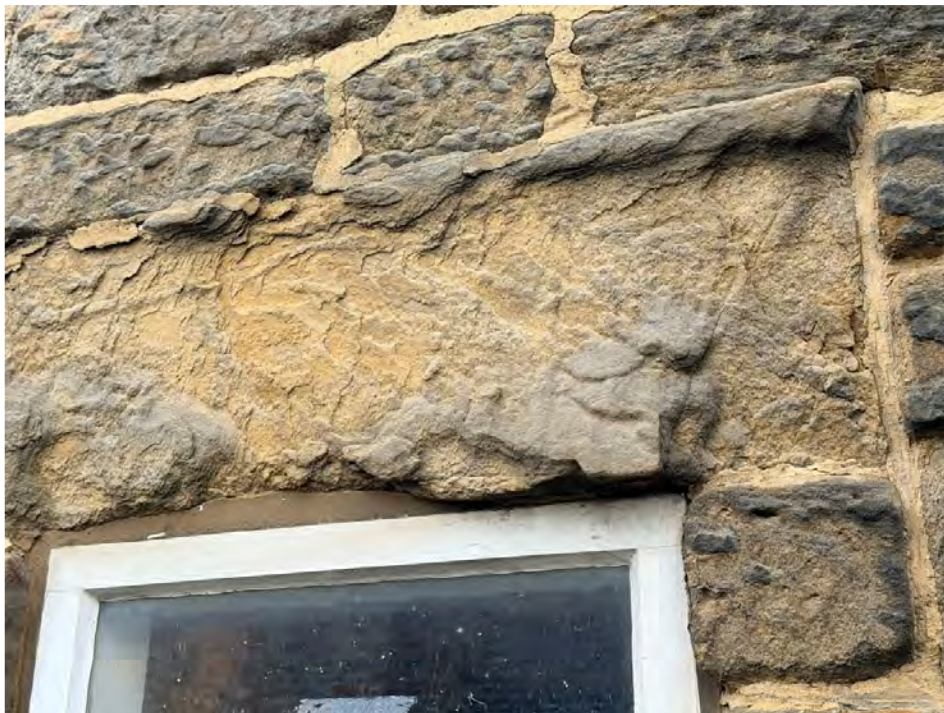
WEATHERED WINDOW HEAD ON WEST ELEVATION

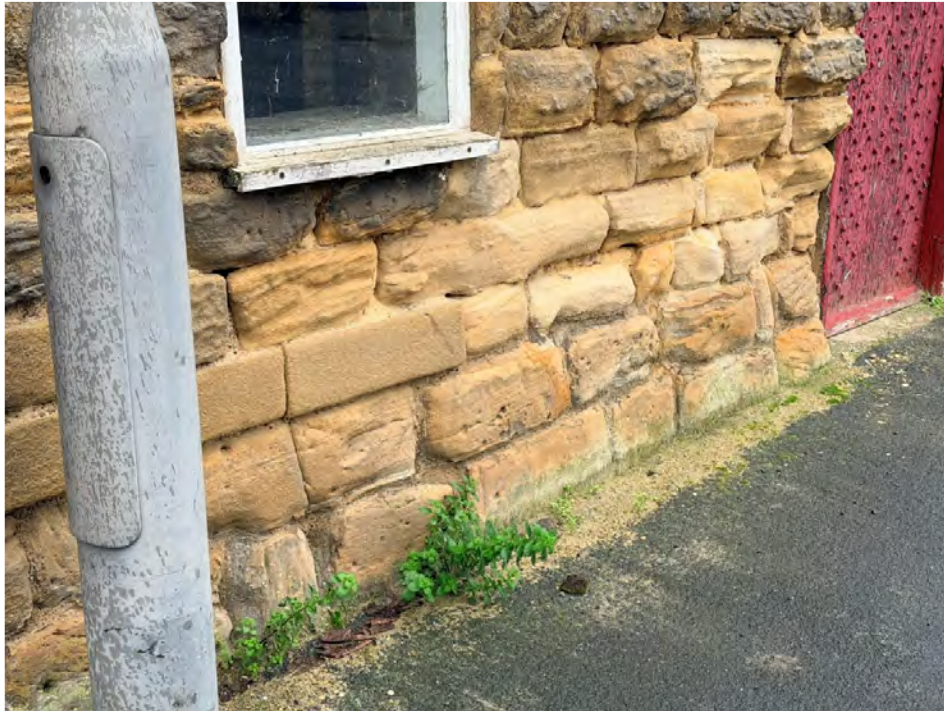
ERODED STONEMWORK AND RECENT REPLACEMENTS ON WEST ELEVATION

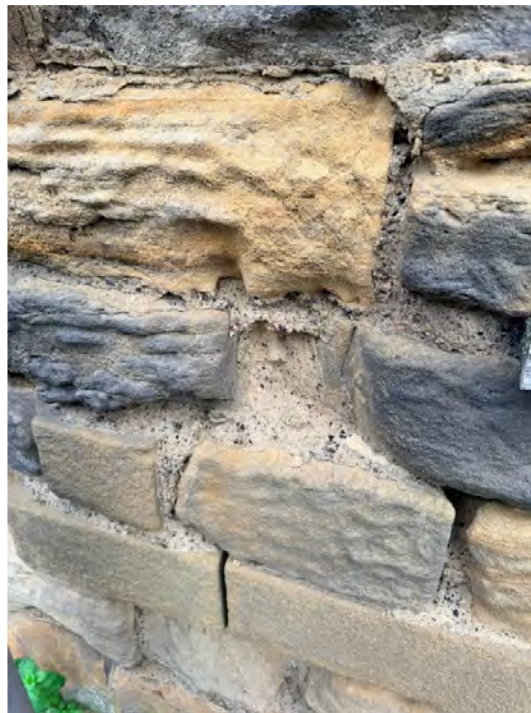
ERODED STONE AND POINTING

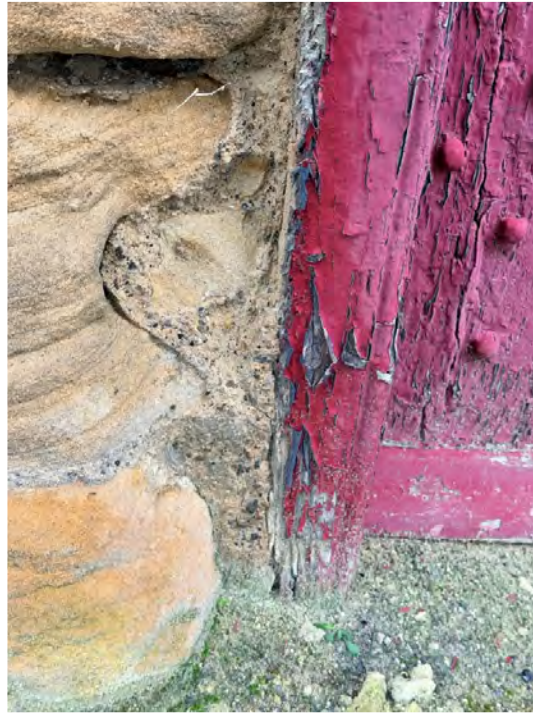
MORTAR REPAIRS AROUND DOOR ALSO ERODING

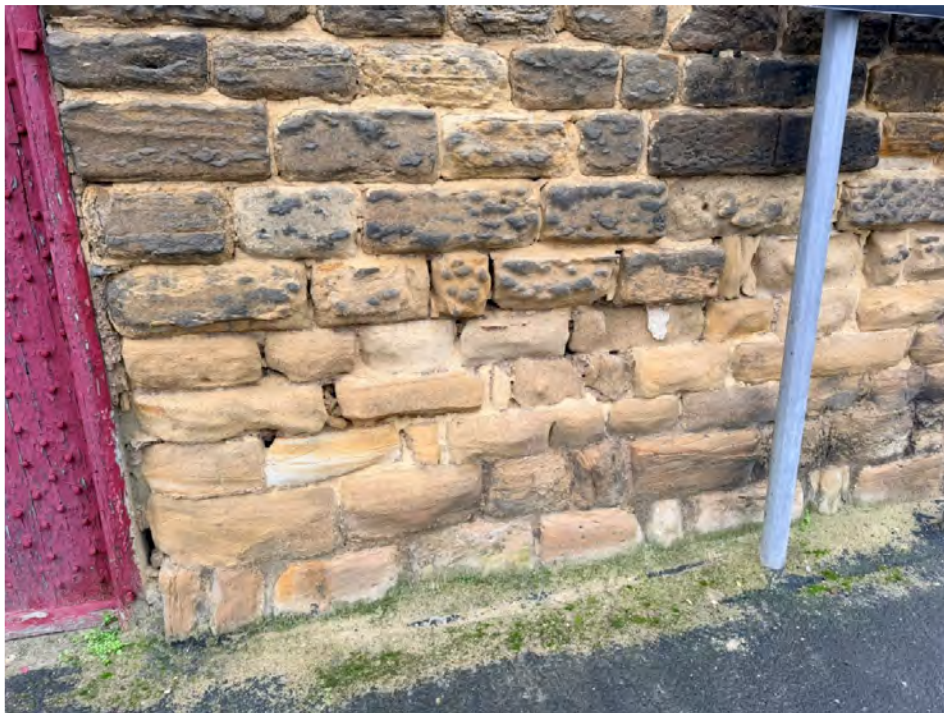
ERODED STONE AND OPEN JOINTS ON WEST ELEVATION

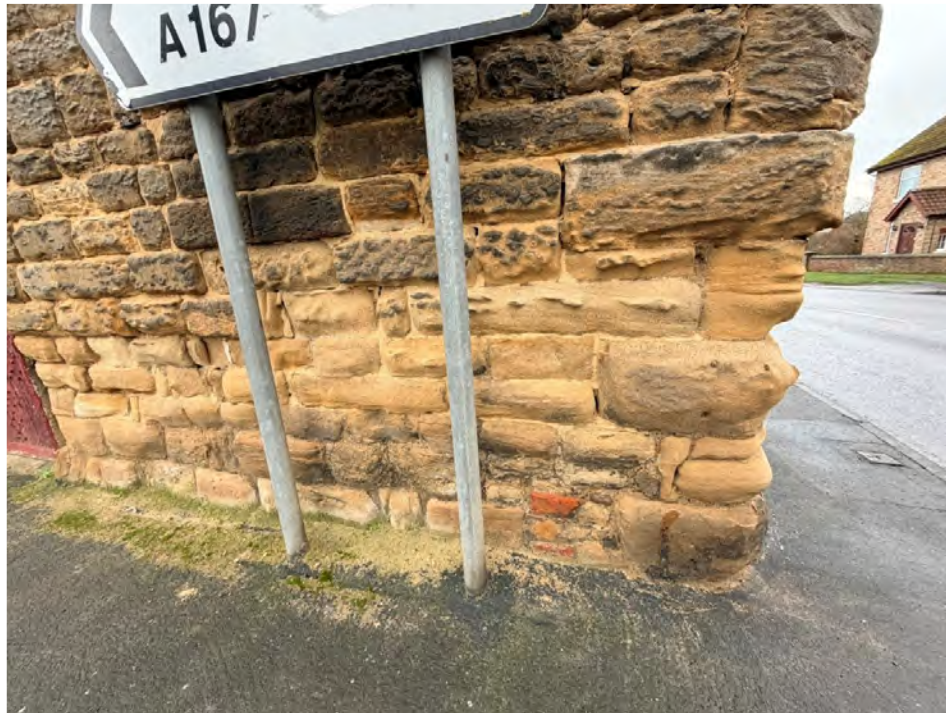
SIGNIFICANT EROSION AT LOW LWVEL TO SOUTH WEST CORNER

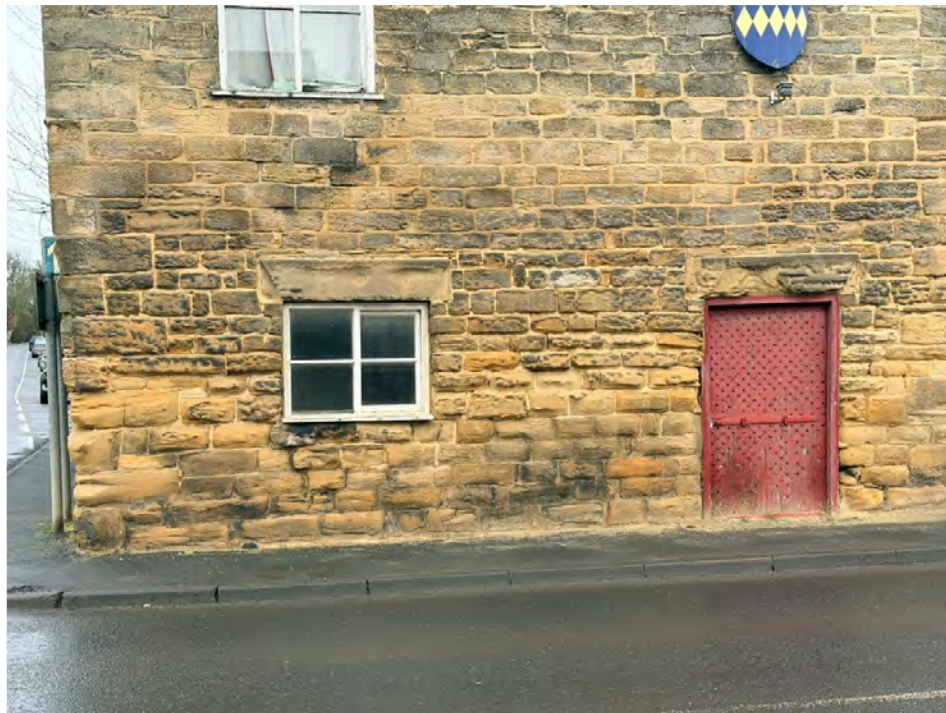
EROSION AND BLACKENING ON SOUTH ELEVATION

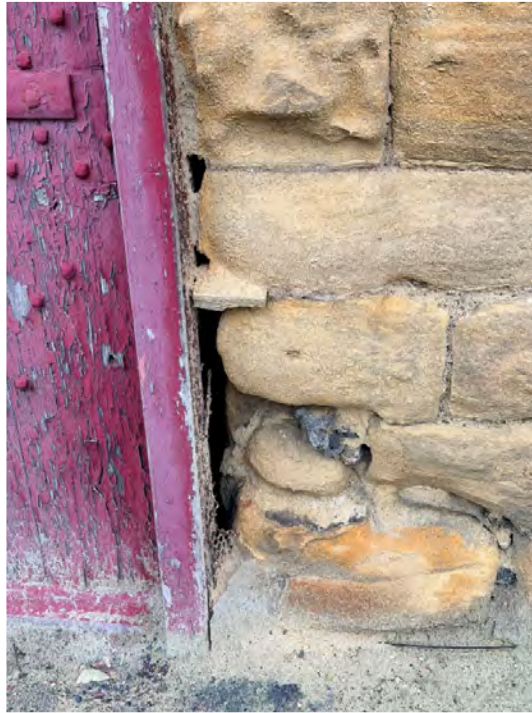
SIGNIFICANT EROSION AROUND SOUTH DOOR LEAVING LARGE GAP

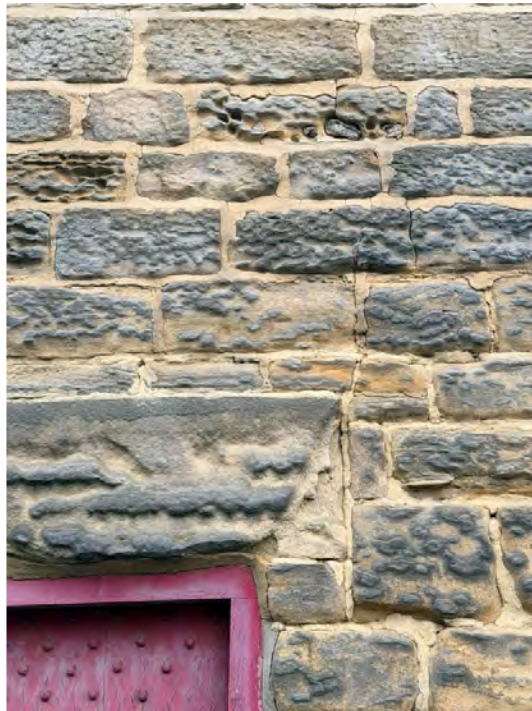
HAIRLINE CRACKING ON SOUTH ELEVATION ADJACENT TO BULGE

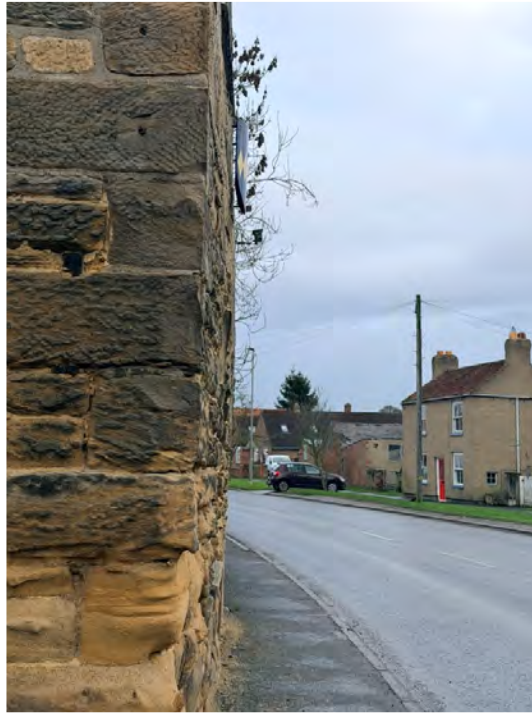
DEFLECTION AND BULGING ON SOUTH WALL

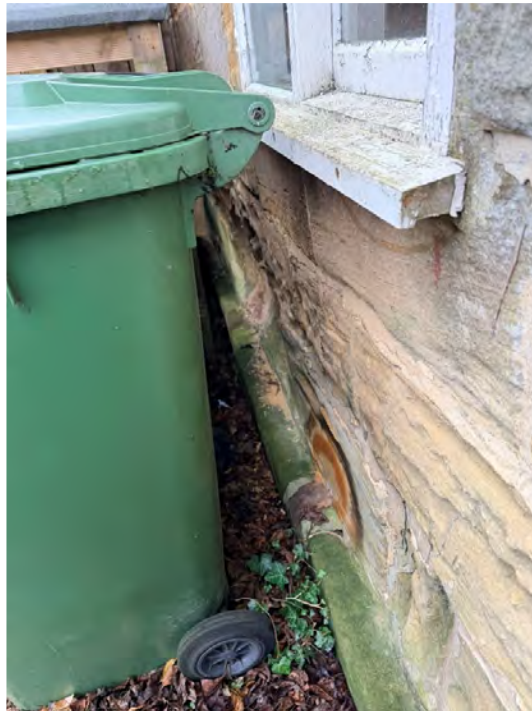
EROSION AT LOW LEVEL ON EAST ELEVATION

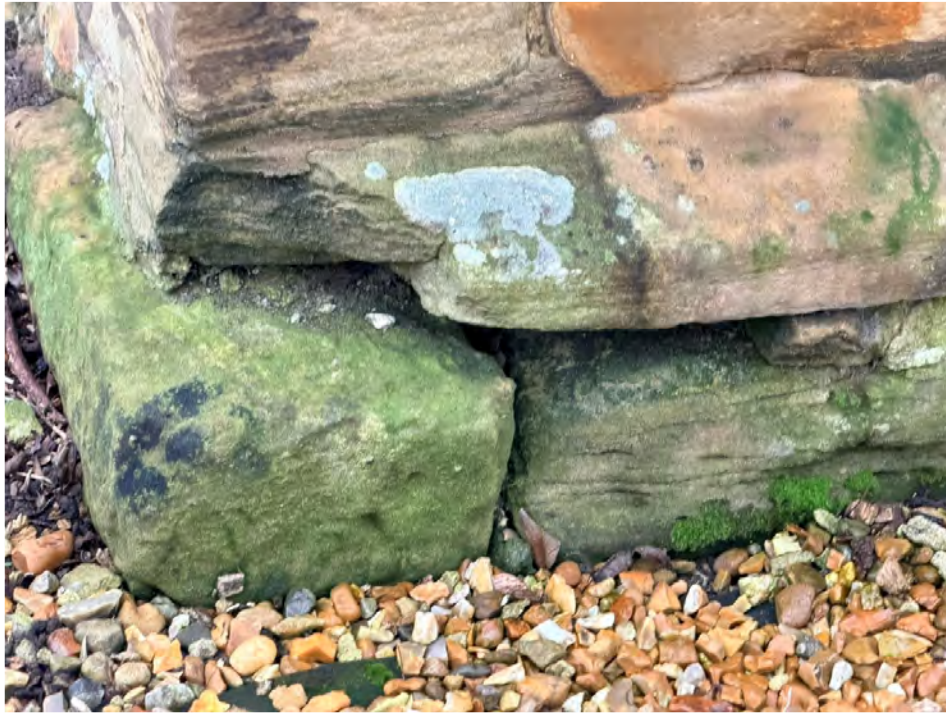
OPEN JOINTS TO NORTH ELEVATION PLINTH

REF.	ELEMENT/LOCATION/ DESCRIPTION	SUMMARY OF CONDITION	DEFECT SOLUTION	PRIORITY, YEAR & APPROXIMATE COST (£k)							
				P	1	2	3	4	5+	Further Investigations	
		<p>Open joints are noted in plinth to north elevation. There is algae and apparent damp staining at low level, likely to be increased by shading and lack of sunlight on wall.</p> <p>Repointing noted to ground floor central section to east elevation. Some erosion to stone at low level.</p> <p>Pointing to west elevation at first floor level generally sound but cracked and friable in many areas to low level.</p>	<p>Included above. The elevation is heavily shaded and benefits from very limited sunlight leading to the dampness and algae growth.</p> <p>Consideration should be given to the installation of a French drain adjacent to the elevation to help relieve/reduce moisture and dampness sitting against the base of the wall.</p> <p>Included above.</p> <p>Included above.</p>	3		0.75

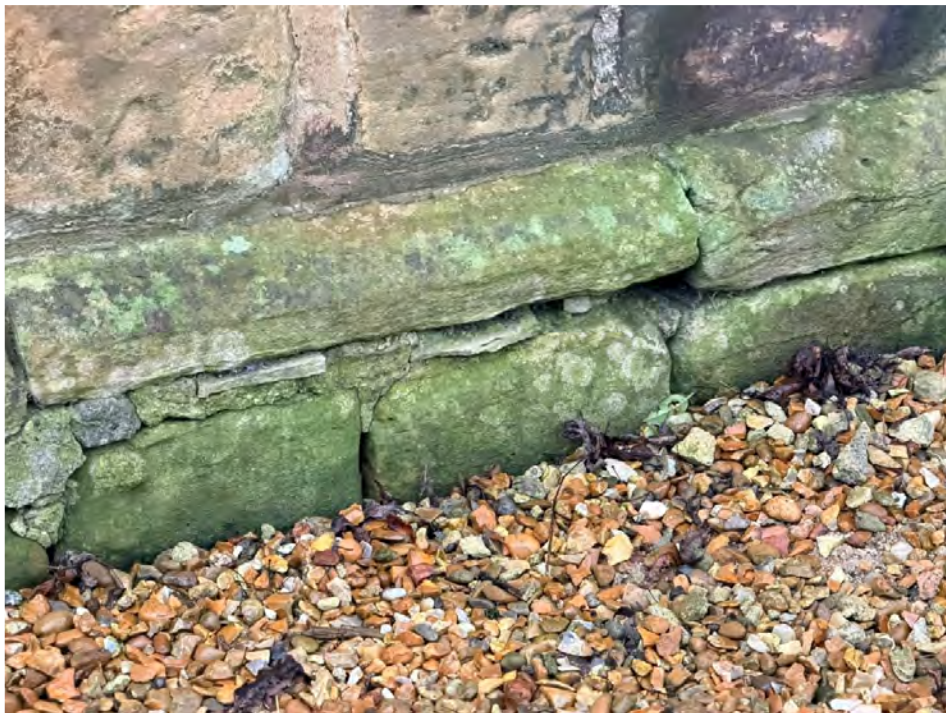
OPEN JOINTS AND ALGAE STAINING ON NORTH PLINTH

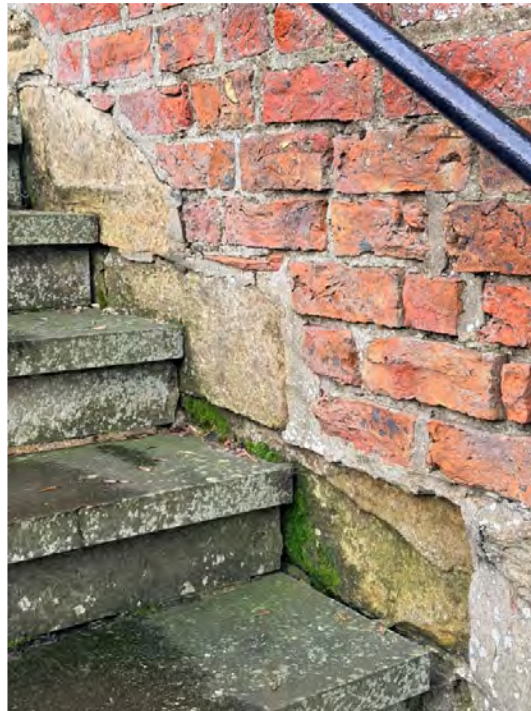
REPLACEMENT CONCRETE STEPS AND EVIDENCE OF FORMER STONE STAIRS

4.7	External Areas									
4.7.1	A flight of steps provide access to the first-floor door on the east side. The steps are of concrete, apparently replacing earlier stone steps, the remains of which can be seen in the north walls.	The concrete steps are not original but are in reasonable condition. The steps may be slippery when wet and moss and vegetation was noted.	Carefully clean the steps to remove vegetation, algae and lichen and apply biocide.	3	0.10		0.10		0.10	
		There are gaps at each edge between the steps and the walls and some pointing is loose.	Repoint steps and fill edges between steps and walls with flexible/compressible filler.	4		0.25

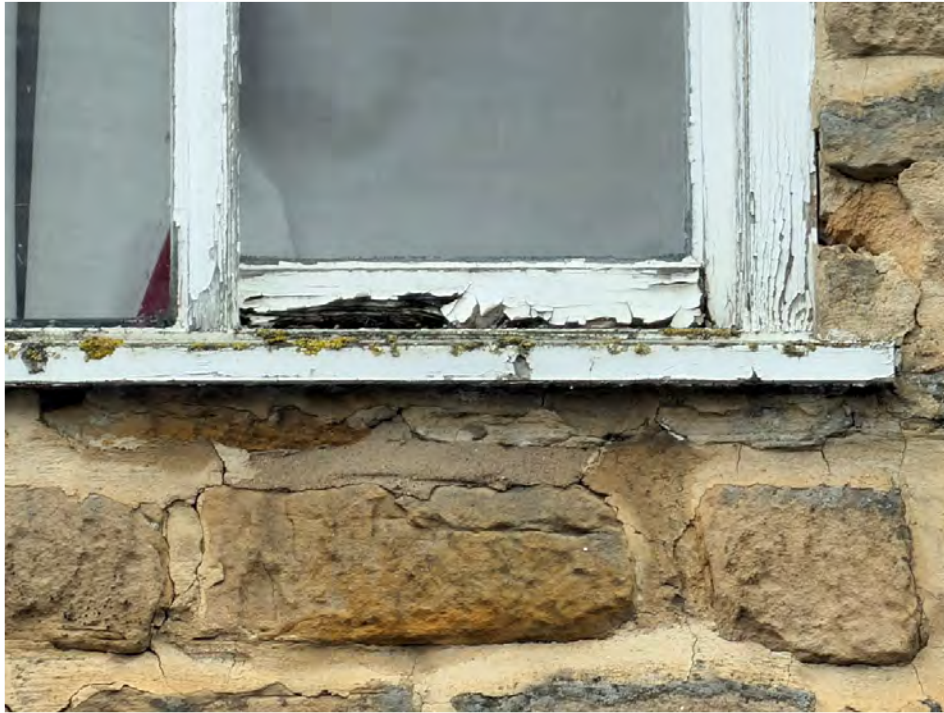
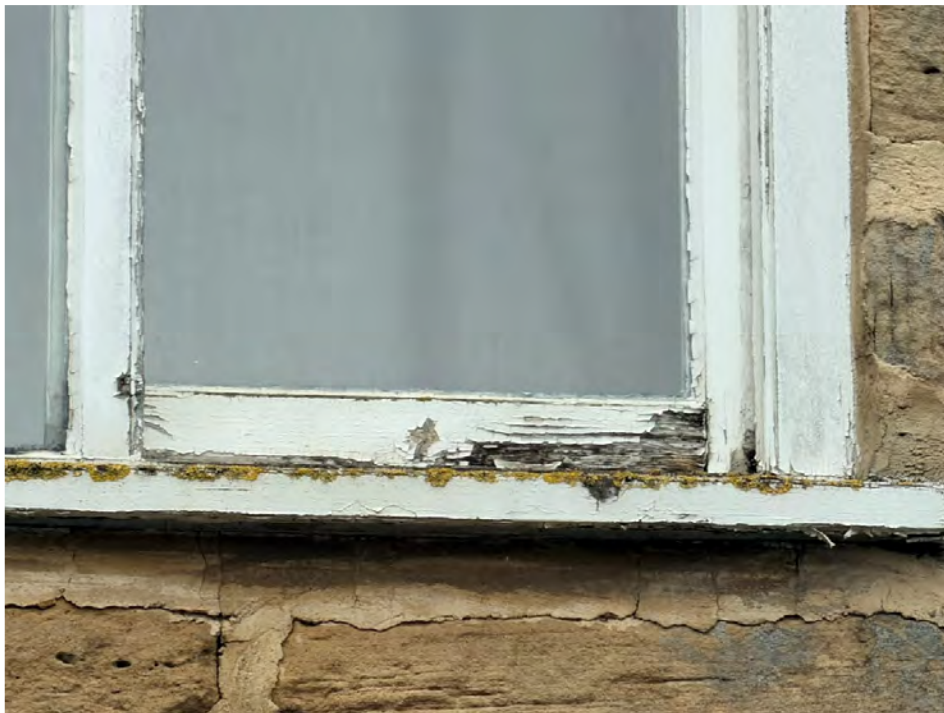
DECAYED TIMBER TO WINDOWS

4		2.00					
4.5	External Windows & Joinery										
4.5.1	Windows are of timber throughout, single glazed and mostly 'Yorkshire' sliding sash with some fixed lights and all are modern replacements of originals.	The windows are painted timber and the decorations are in poor condition leading to decay of the timber members in some areas. Windows must be operable to allow for suitable ventilation of the internal spaces.	Fully overhaul all windows to ensure adequate operation, repair defective timber and fully prepare and redecorate.	2	2.00

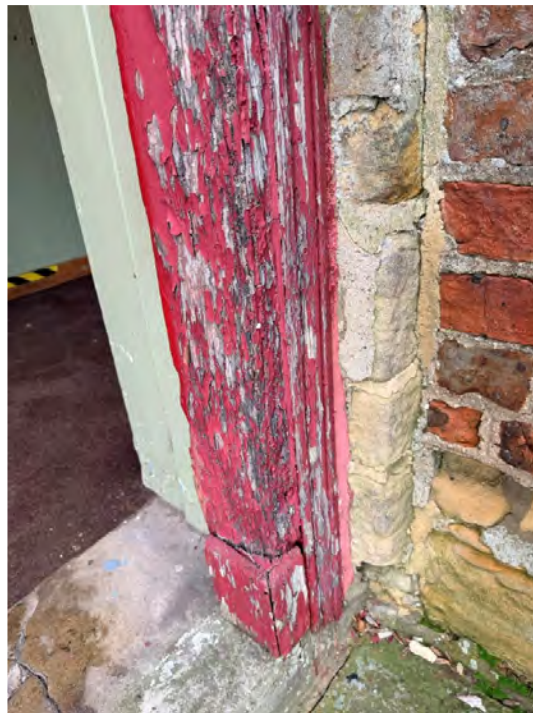
DETERIORATED FRAME TO SNOOKER CLUB DOOR

4.6	External Doors										
4.6.1	6 panelled timber external door to first floor level, with boarded timber on reverse side and strap hinges, set within timber frame.	Operational and lockable but otherwise in poor condition. Decorations have not been maintained properly and are in very poor condition together with extensive decayed timbers.	Full overhaul, restoration and repair of door required including replacement of decayed timber to door and frame. Overhaul ironmongery as required and install new locks etc.	4	1.20						
		The door appears to have been adjusted in the past to accommodate historic movement.	Adjust as required to ensure secure fit.	3	0.25

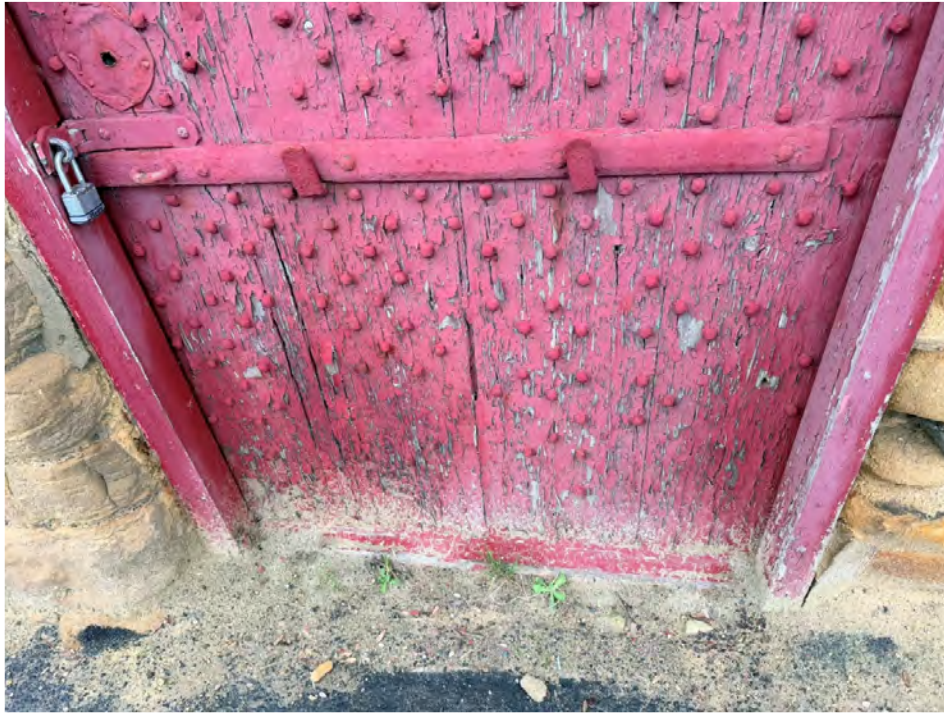
AGED AND DETERIORATED DOOR TO SOUTH ELEVATION

4.6.2	The remaining doors are formed with wide timber boards with studs to front face. Doors have been cross boarded to the rear, are set within timber frames and include strap hinges.	Operational and lockable but otherwise in poor condition. Decorations have not been maintained properly and are in very poor condition together with extensive decayed timbers.	Full specialist overhaul, restoration and repair of door required including replacement of decayed timber to door and frame. Overhaul ironmongery as required.	4	1.20						
		The doors do not properly fit in the openings and are unlikely to be capable of providing a weathertight, secure installation.	Depending upon future uses, an alternative solution may need to be found to provide security and weathertightness. Listed Building Consent will be required.	3	0.25

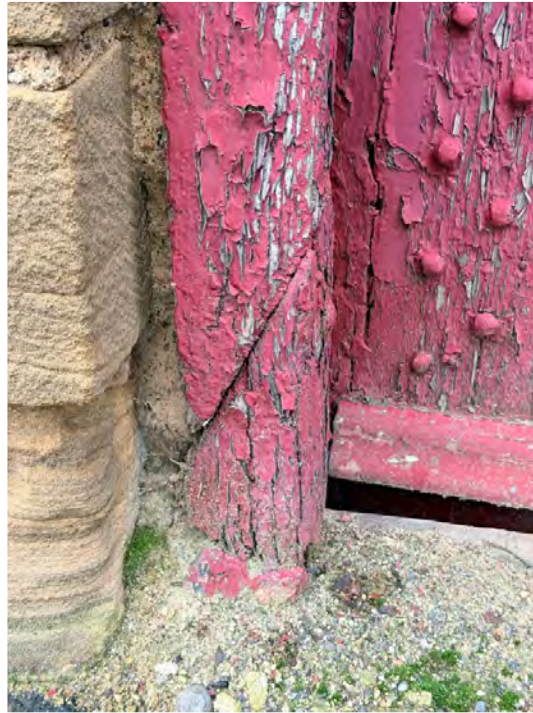
DETERIORATED FRAME TO WEST ELEVATION DOOR

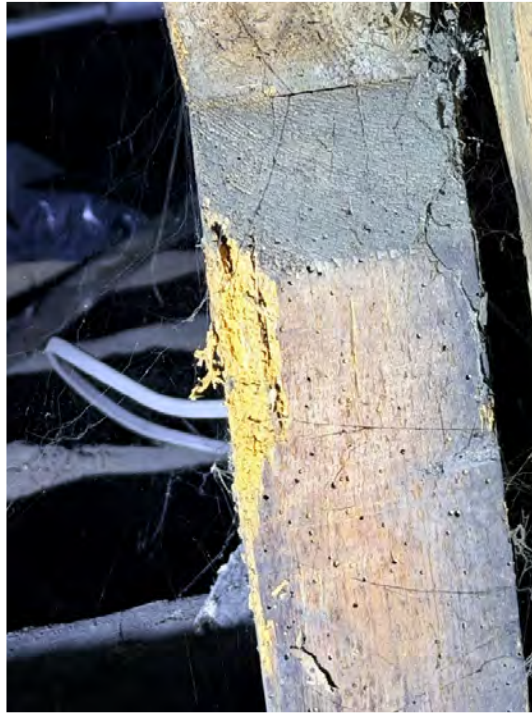
WOOD BORING INSECT ATTACK TO ROOF TIMBERS

4.8	Roof Space									
4.8.1	A small area of roof space is located over the south end of the first floor, accessed via a timber door. We did not enter the roof void, and the inspection was carried out from the hatch location.	Bitumen felt is provided to the underside of main roof, visible in roof void. There was no evidence of any ongoing leaks within the roof void where we were able to inspect, and the roof timbers appeared to be sound where visible.	No significant structural works required where we were able to inspect.							
		Some evidence of wood boring insect attack to some roof timbers	Any infestations may be historic or inactive but precautionary treatment is recommended	3	1.50

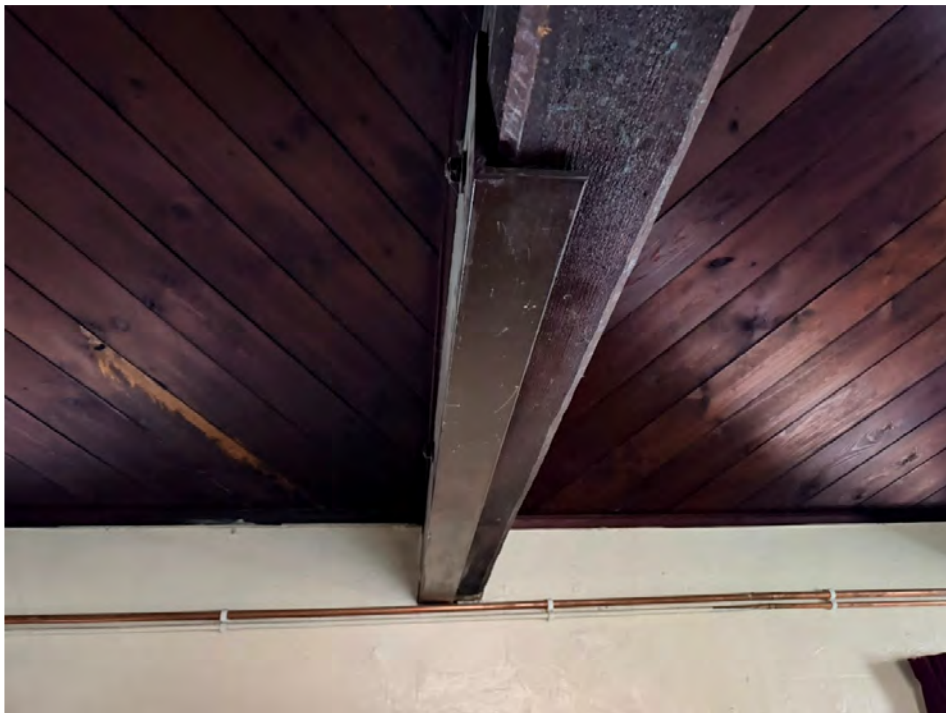
STEEL REPAIR TO ROOF TRUSS

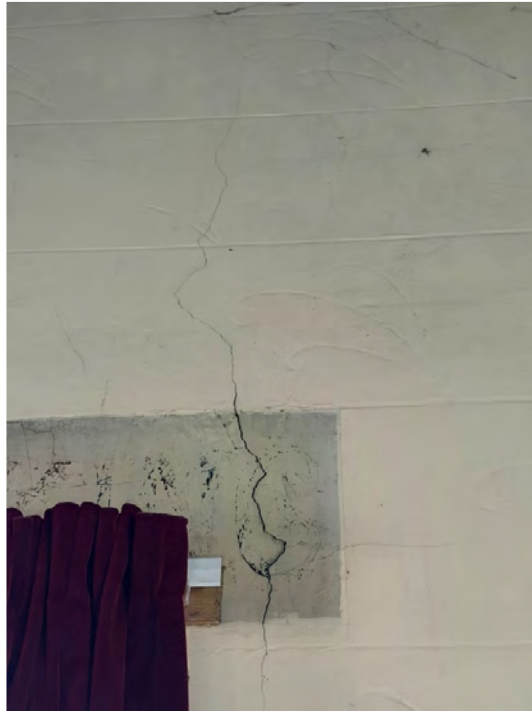
HAIRLINE CRACKING IN PLASTER TO NORTH WALL

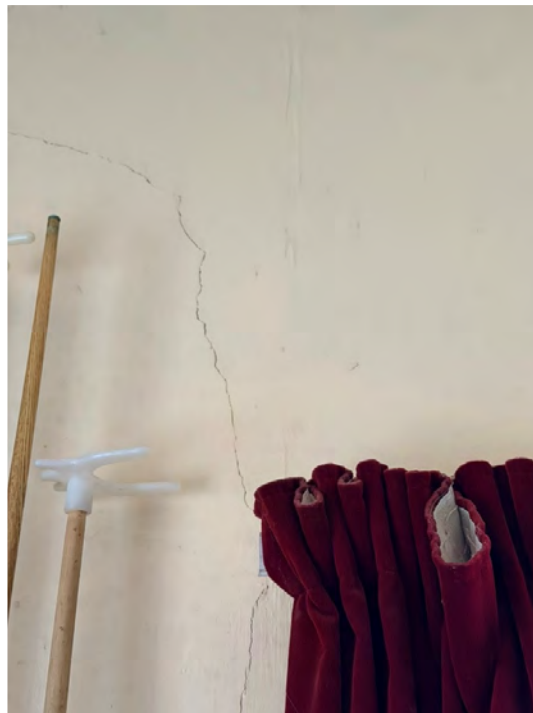
HAIRLINE CRACKING ON WEST WALL

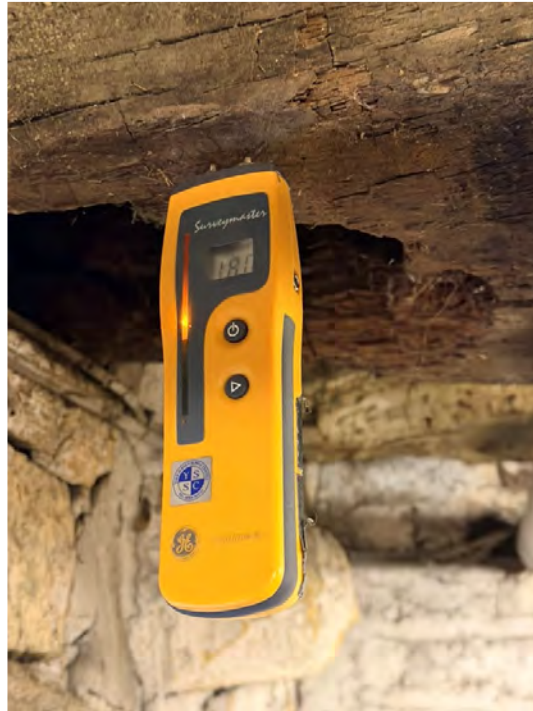
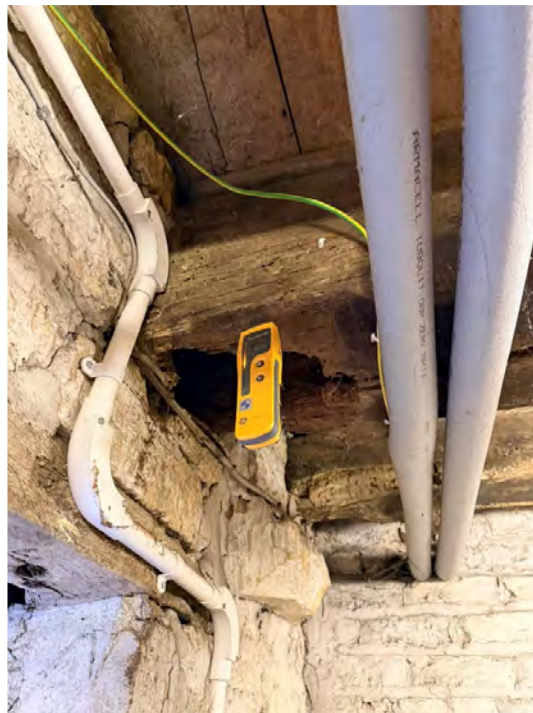
MODERATE MOISTURE READINGS IN FIRST FLOOR TIMBERS

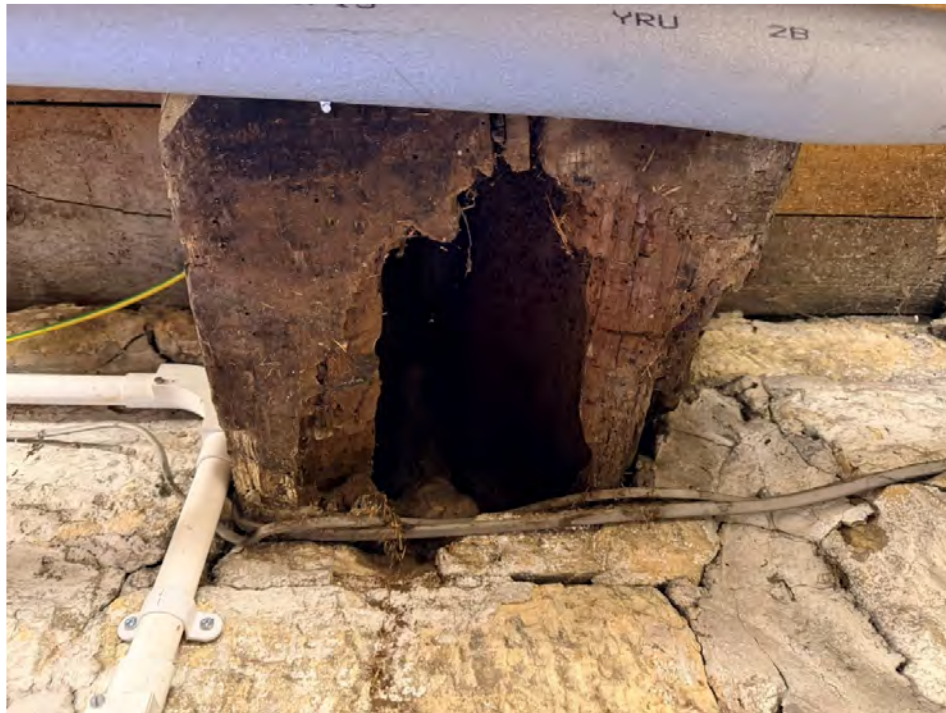
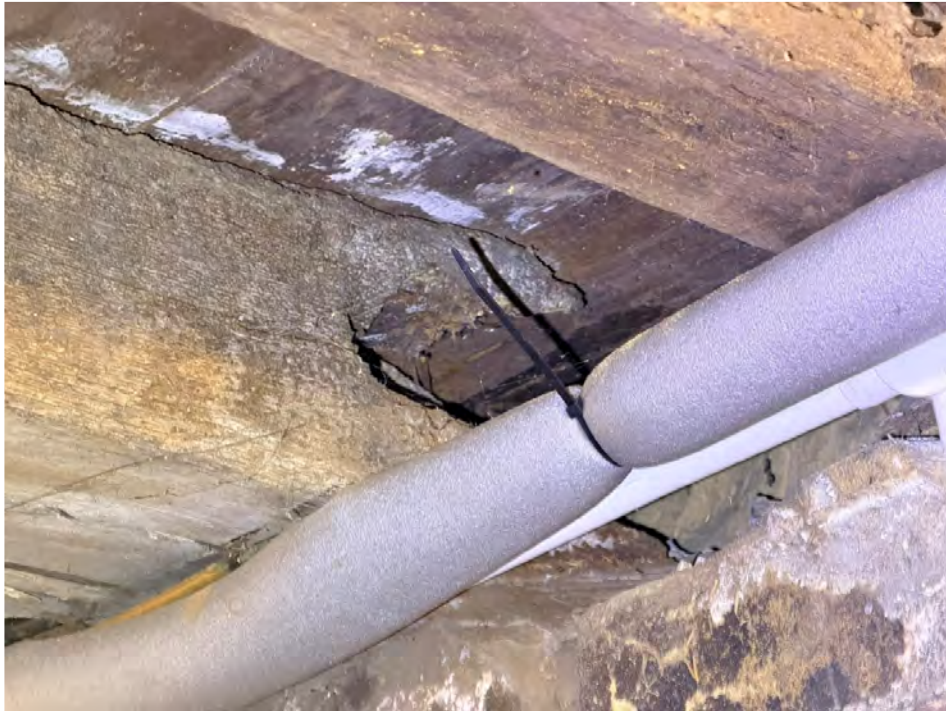
DECAYED FLOOR JOISTS ENDS DUE TO DAMPNESS AND INSECT ATTACK

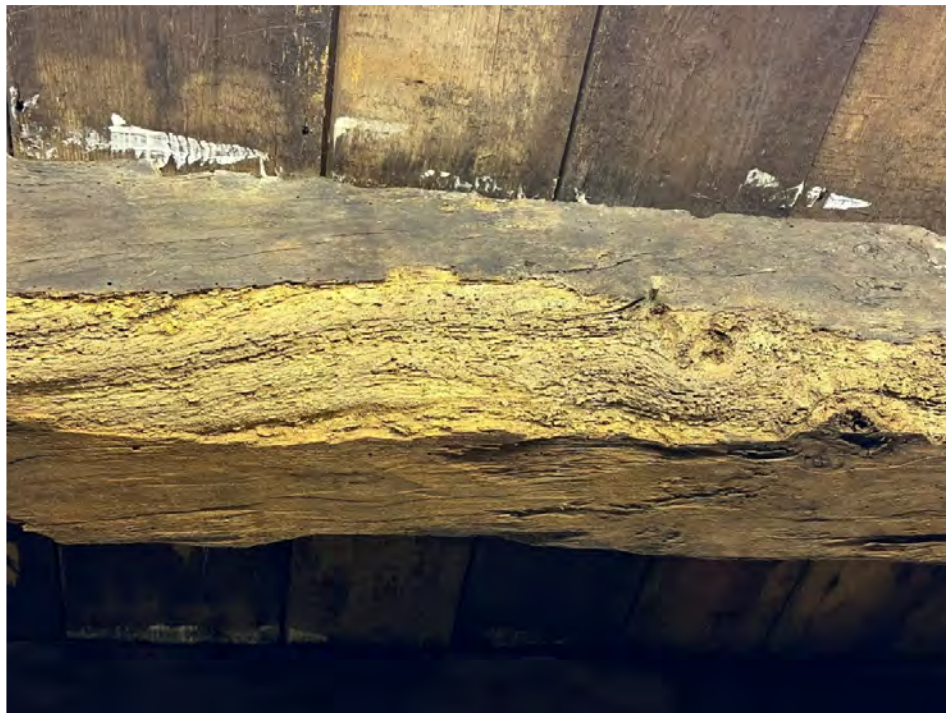
DAMAGED RESULTING FROM WOOD BORING INSECT ATTACK

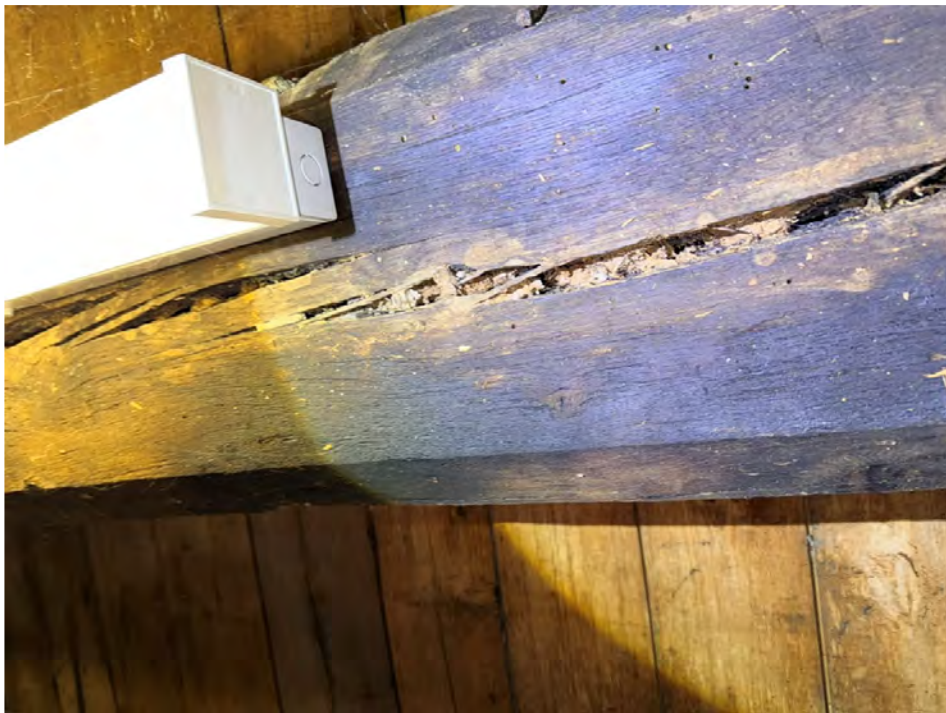
SIGNIFICANT SHAKE IN FLOOR TIMBER
