CONDITION SURVEY

The Old Tolbooth, Topcliffe

Condition Survey

Is1104-25 Condition Survey Report Rev A November 2025

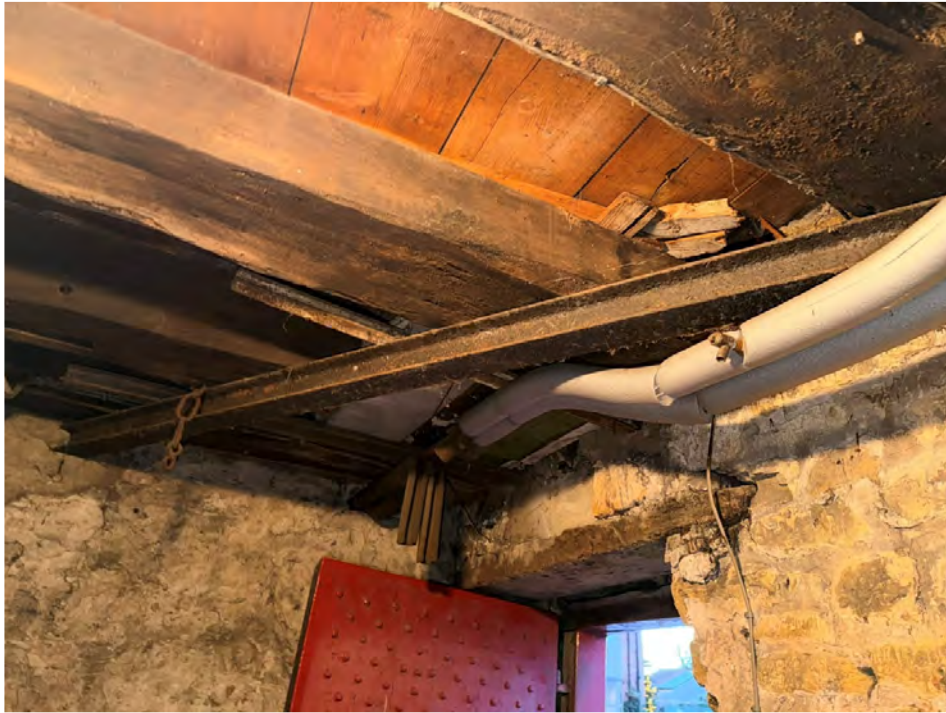
HSITORIC REPAIR AND STEEL SUPPORT TO FIRST FLOOR JOISTS

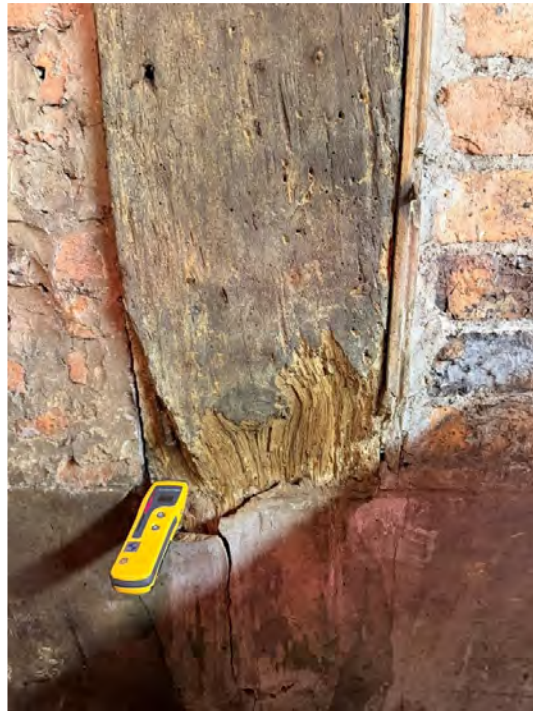
HIG MOISTURE READINGS IN TIMBER TO GROUND FLOOR PARTITION

4.10.5	Timber framed open partition to central section of spine wall.	<p>Large section timber uprights with large timber beam providing support to floor beams passing above. Wood boring beetle attack is widespread but given the section of the timbers is unlikely to have affected structural performance.</p> <p>Timbers have been significantly decayed by insect damage from wood boring beetles.</p> <p>Recent brick plinths appear to have been provided to base of uprights.</p>	No evidence of active attack is present, but a precautionary treatment is recommended.	3		4.00

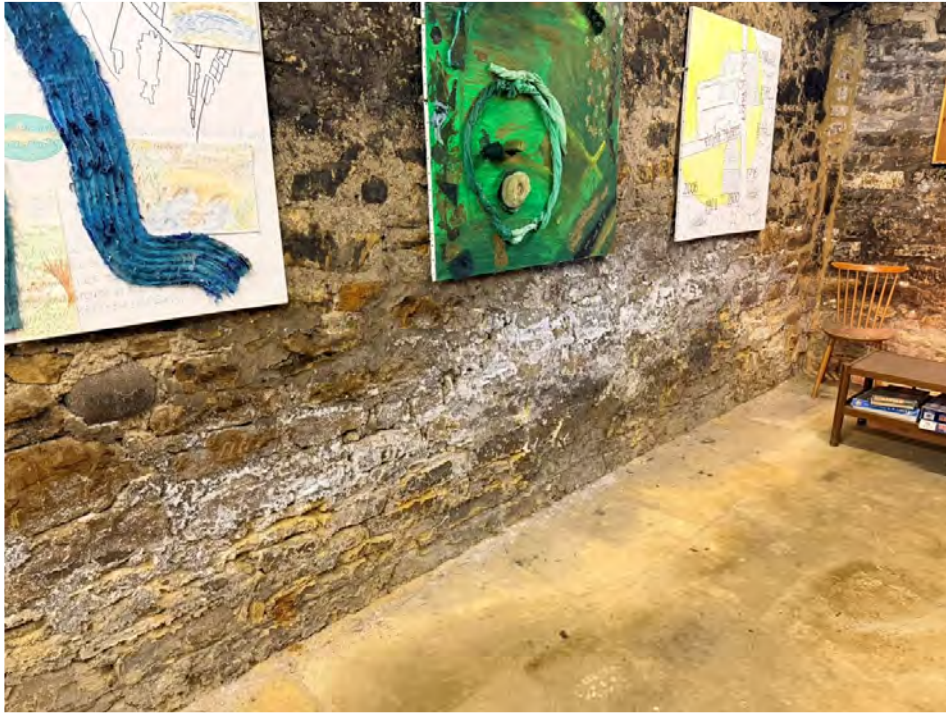
SALT STAINING AND DAMPNESS TO DIVIDING WALL

4.10.3	Solid masonry internal wall at ground floor running north/south, comprising brick and stone with plaster to some areas.	High dampness levels are evident at lower level to much of the wall and extending to the inner face of the external walls, evidenced by salts on the surface. Salts rise up to between 900 and 1200 mm.	Brush off salts as a short-term measure. Improve ventilation/air movement (fans and dehumidifiers may help) and provide a low level of background heating as appropriate.	3	0.75						A/B
		Previous DPC installations such as an electro-osmotic system are noted. Such systems are generally ineffective, particularly in walls like this.									
		Such dampness will, over time cause deterioration of the stonework and	Improve ventilation and air movement (fans and dehumidifiers may help) and provide a low level of background heating as appropriate.	3		3.0					
			Further consistent measures to manage the moisture and dampness will require consideration in due course. This may include additional heating, passive or mechanical ventilation / extraction. No cost included here.	4							B

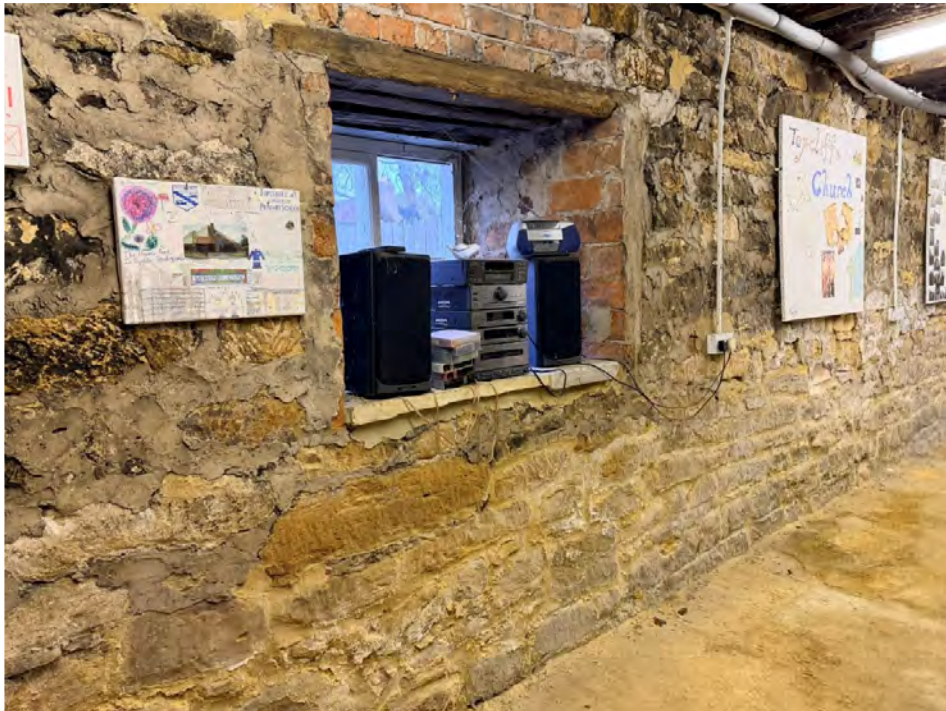
SALT STAINING AND DAMPNESS TO EXTERNAL WALL

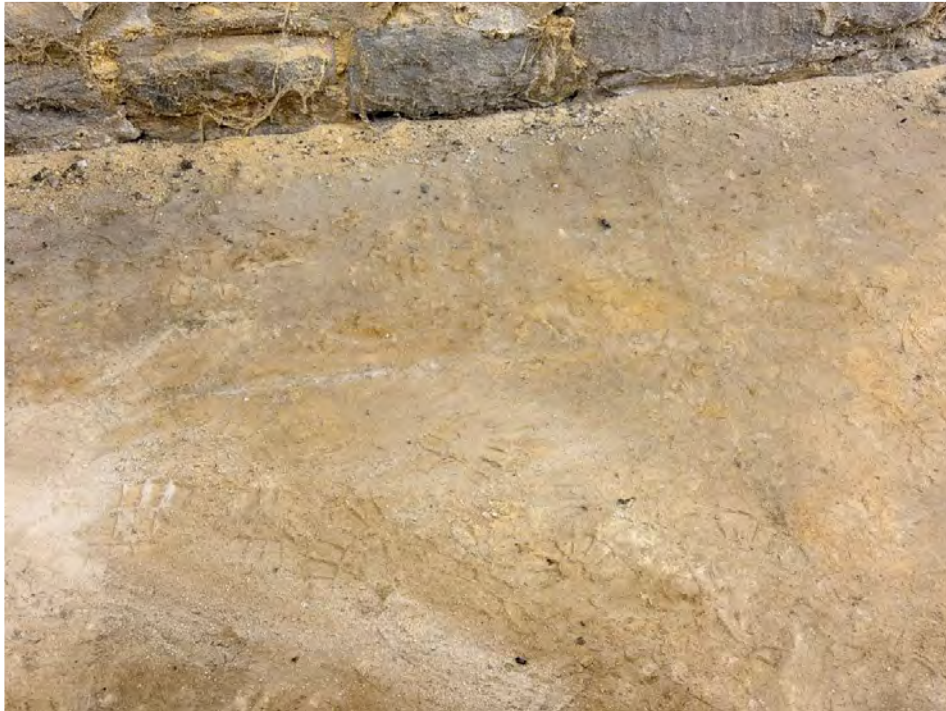
STAINING AND DUSTING OF DAMP FLOOR SLABS

4.11.3	The ground floor comprises stone flags to the east section and a raised concrete floor to the stables area.	The stone slabs are suffering from dampness evident on the surface, while the concrete floor is in serviceable condition and suitable for current use.	The dampness to the ground floor will be difficult to fully address without lifting and renewing the flags on a new concrete base. However, the dampness may be managed to an acceptable level in conjunction with the measures noted above.	4		Inc above

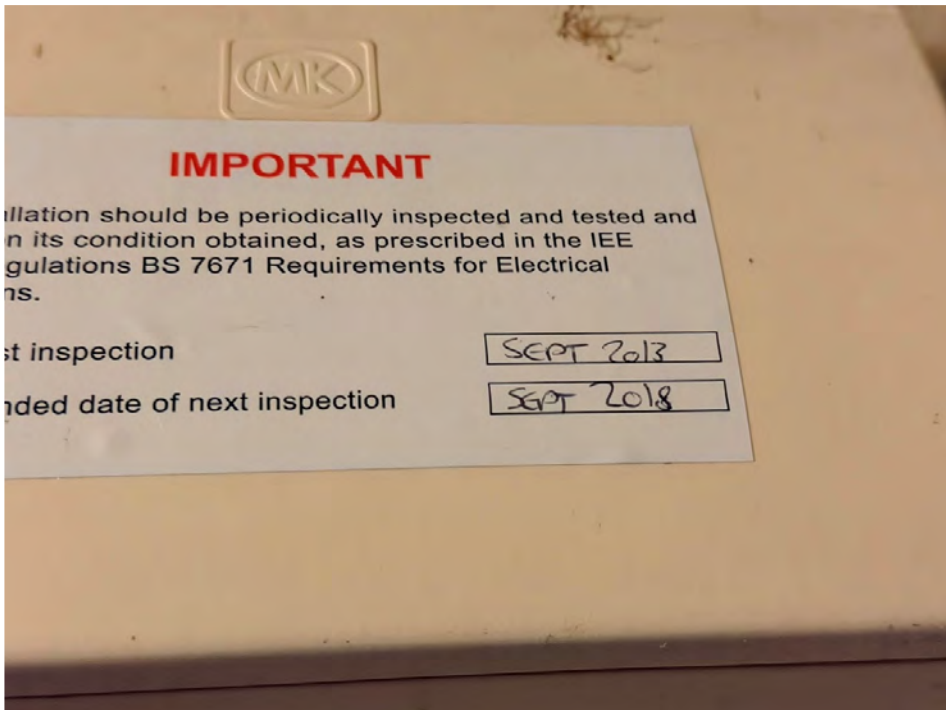
OVERDUE TEST LABELS TO DISTRIBUTION BOARD ON FIRST FLOOR
