CONDITION SURVEY

The Old Tolbooth, Topcliffe

Condition Survey

Is1104-25 Condition Survey Report Rev A November 2025

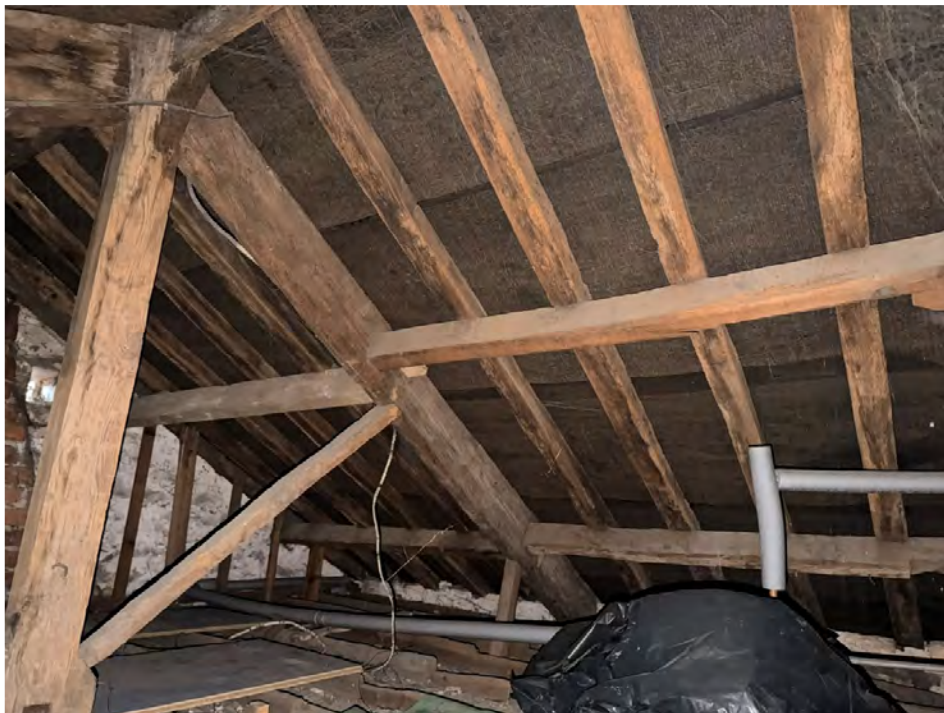
ROOF VOID SHOWING BITUMEN UNDERFELT

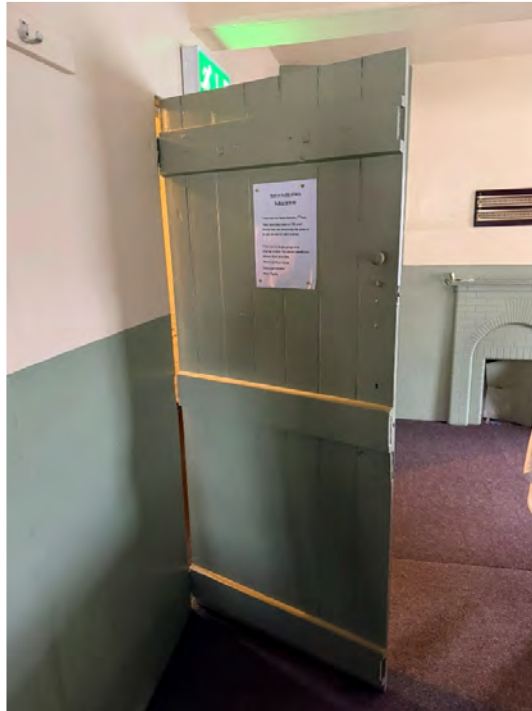
DOOR TO SNOOKER ROOM

4.12	Internal doors and joinery										
4.12.1	Boarded timber door to snooker room.	Generally serviceable condition but sticking slightly in the frame. Dependent upon future use the door may need to be upgraded to meet fire resistance requirements.	Ease and adjust door to ensure proper operation.	4	0.25
